# HALFWAY RANGER STATION HISTORIC DISTRICT

## §106 RESOURCE AND BOUNDARY DELINEATION REPORT

October 28, 2009

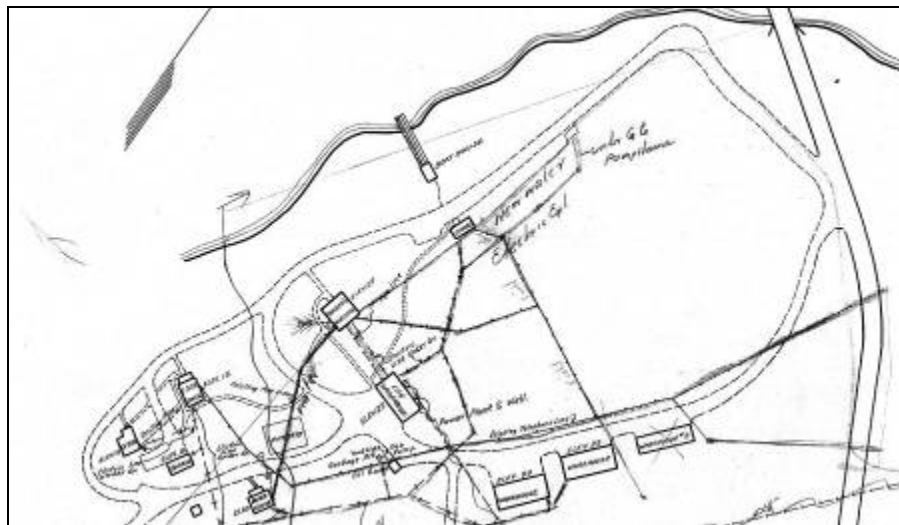
Figure 1. Halfway Ranger Station Road System (1937)

The HRSHD road system closely resembles the 1930s road system with few alterations. The site is still accessible at two points along State Highway 1, although the southern-most access road is now the site's primary entrance (See Figures 1 and 2 below for a description of specific road characteristics and alterations). Overall, the road system has retained a preponderance of integrity and is considered a contributing element of the historic district.

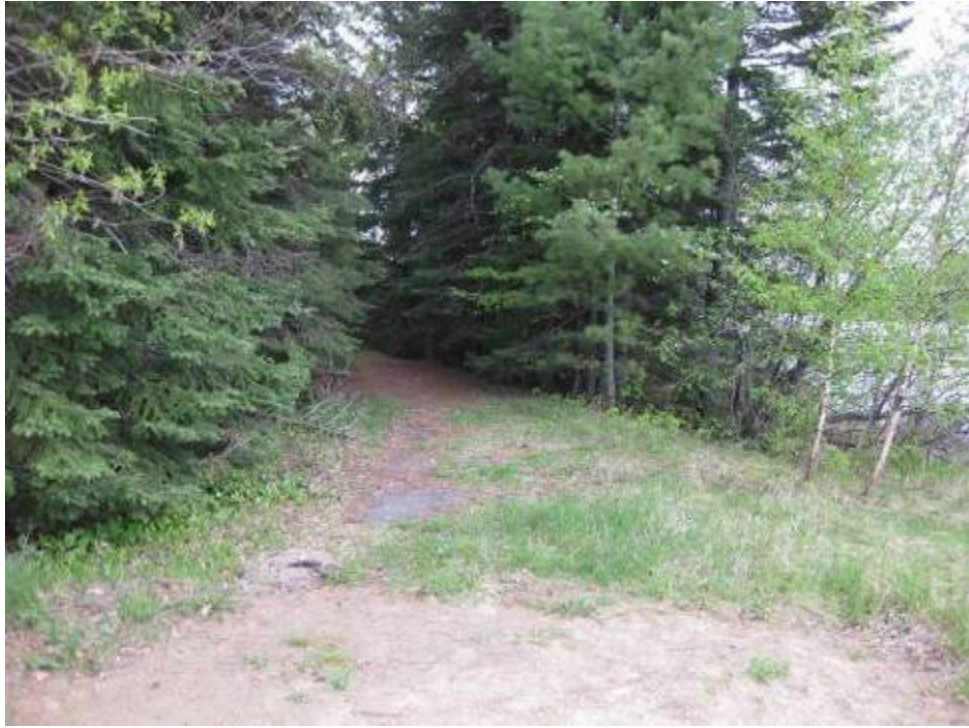
This northernmost entrance remains and has retained a preponderance of integrity. (See Figure 3)

**Figure 3.** Northernmost highway access point is seldom used but has retained a preponderance of integrity and is considered a contributing feature of the historic district. (J. Ferguson: June 2, 2009)

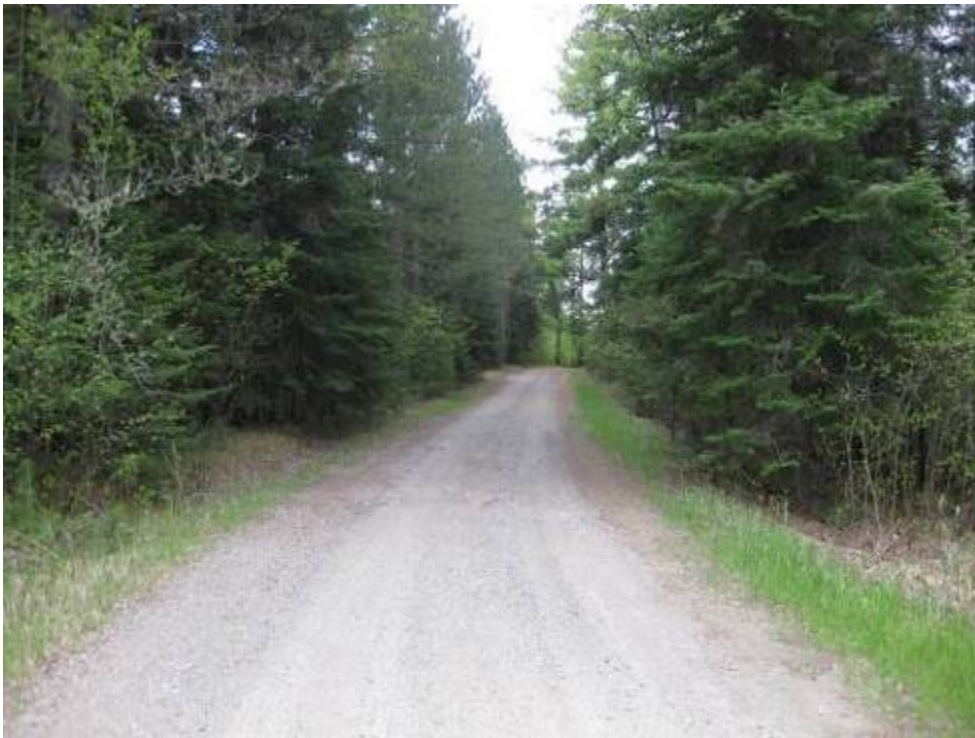
This segment is the primary roadway and it retains a preponderance of integrity. (See Figures 4 & 5)

**Figure 4.** Primary access road has retained a preponderance of integrity and is considered a contributing feature of the historic district. (J. Ferguson: June 2, 2009)

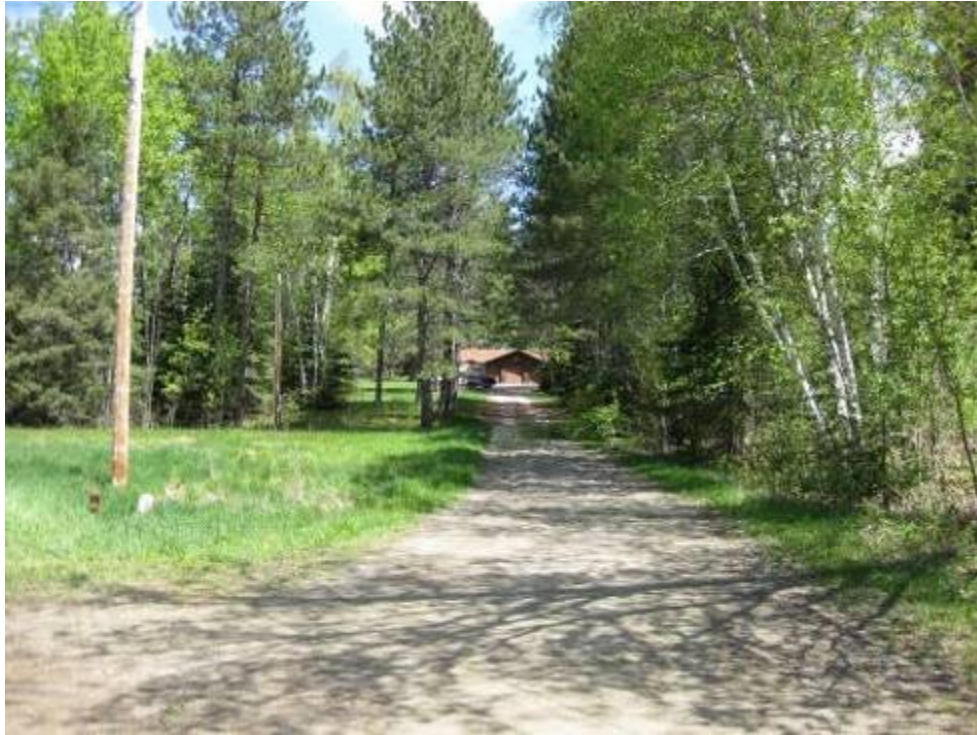
**Figure 5.** Primary road accessing the LSFES portion of the District has retained a preponderance of integrity and is considered a contributing feature of the historic district.  
(J. Ferguson: June 2, 2009)

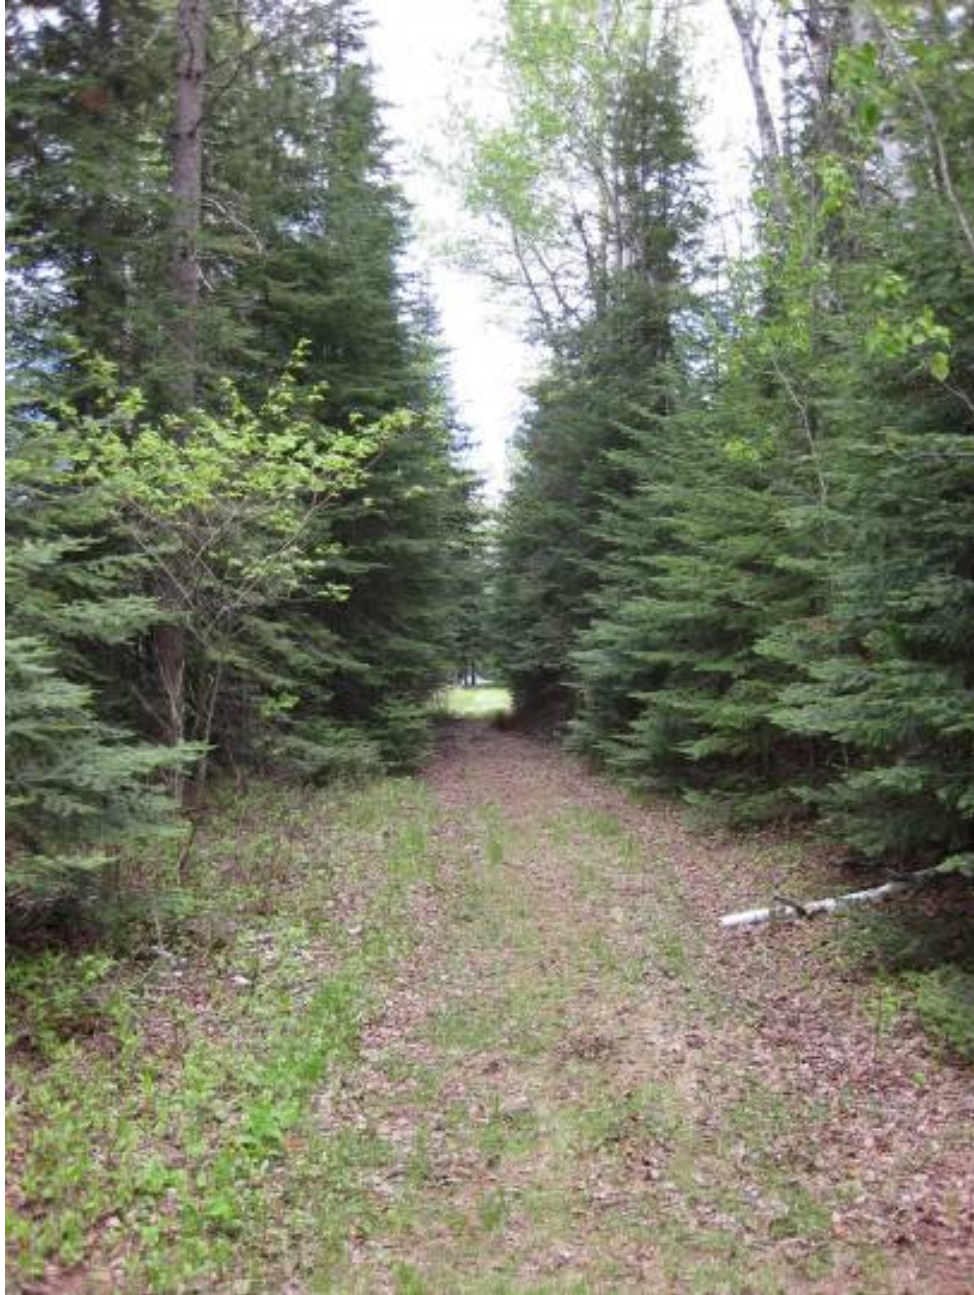
**Figure 6.** Road adjacent to the South Kawishiwi River is seldom used but has retained a preponderance of integrity and is considered a contributing feature of the historic district. (J. Ferguson: June 2, 2009)

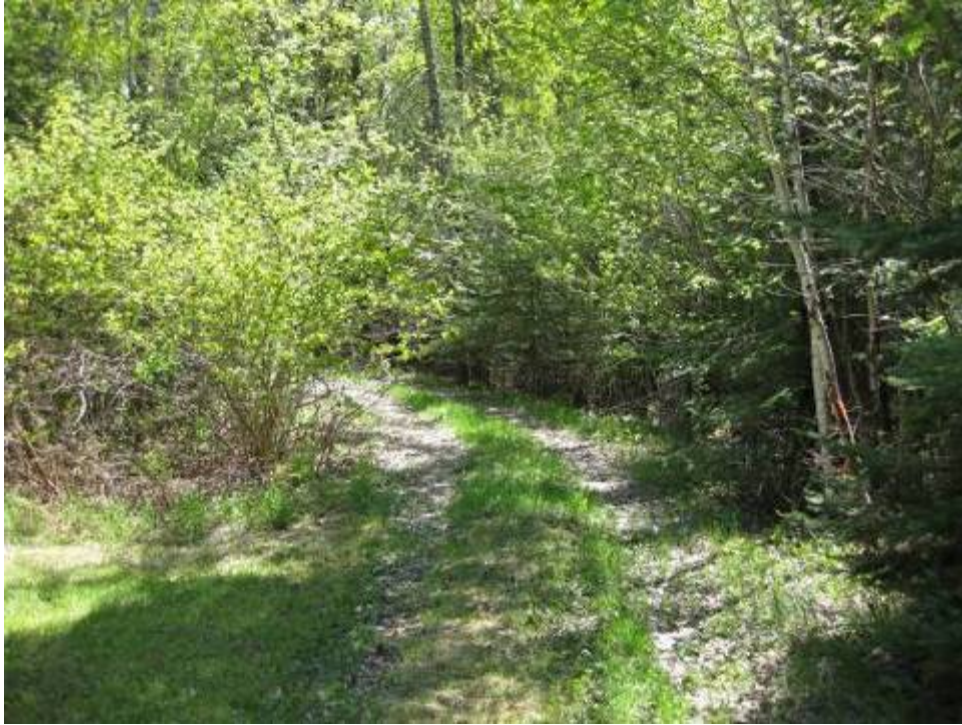
Historic road segment still exists but is seldom used and somewhat overgrown but it retains a preponderance of integrity. (See Figure 7)

**Figure 7.** Road crossing between the access roads has retained preponderance of integrity and is considered a contributing feature of the historic district. (J. Ferguson: June 2, 2009)

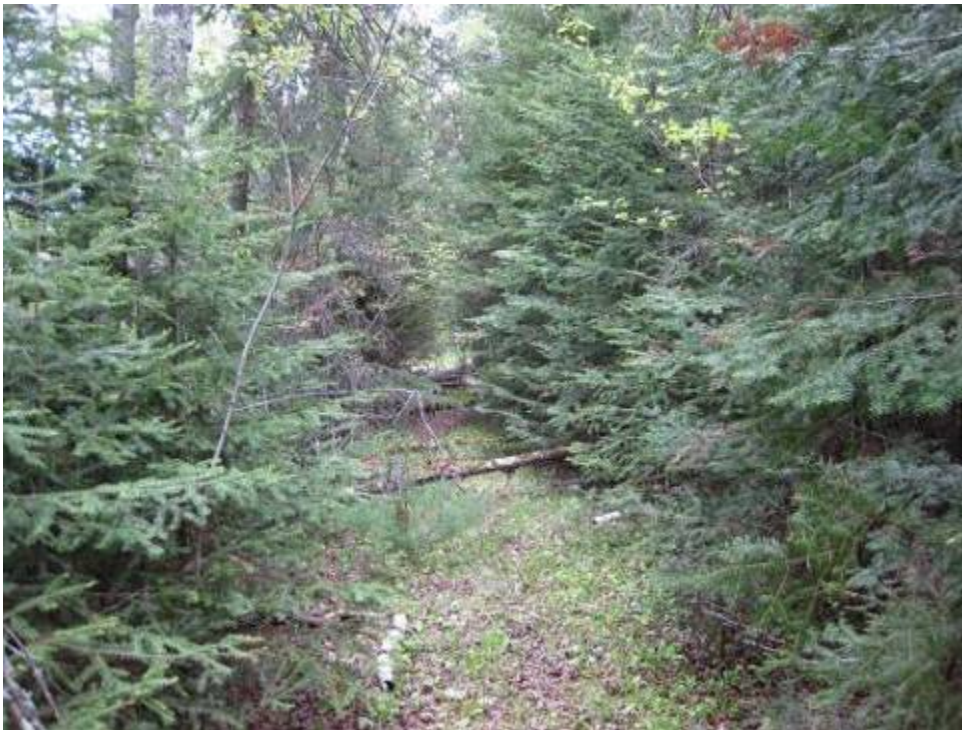
Historic road segment is considerably overgrown but retains a preponderance of integrity. (See Figure 8)

**Figure 8.** Southernmost portion of road adjacent to the river is considerably overgrown but has retained integrity and is considered a contributing feature of the historic district. (J. Ferguson: June 2, 2009)

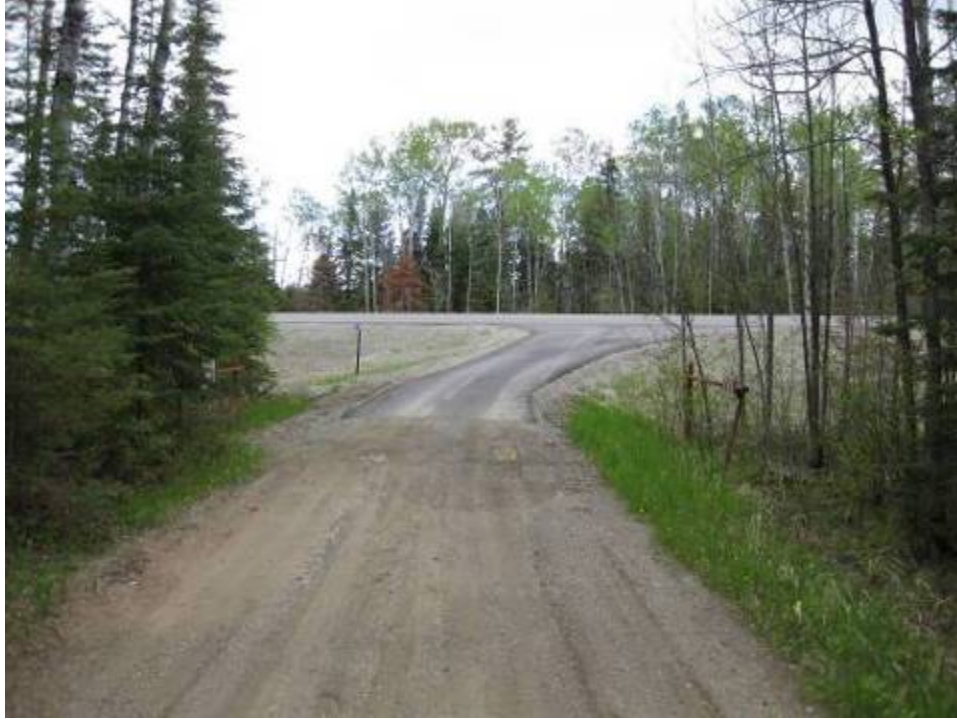
The historic road system still intersects the Highway at both points, although this entrance has been significantly altered as a result of recent highway construction which widened the roadway. (See Figure 9)

**Figure 9.** Southernmost entrance from HWY 1 has been altered due to road construction and is considered a non-contributing feature of the historic district. (J. Ferguson: June 2, 2009)

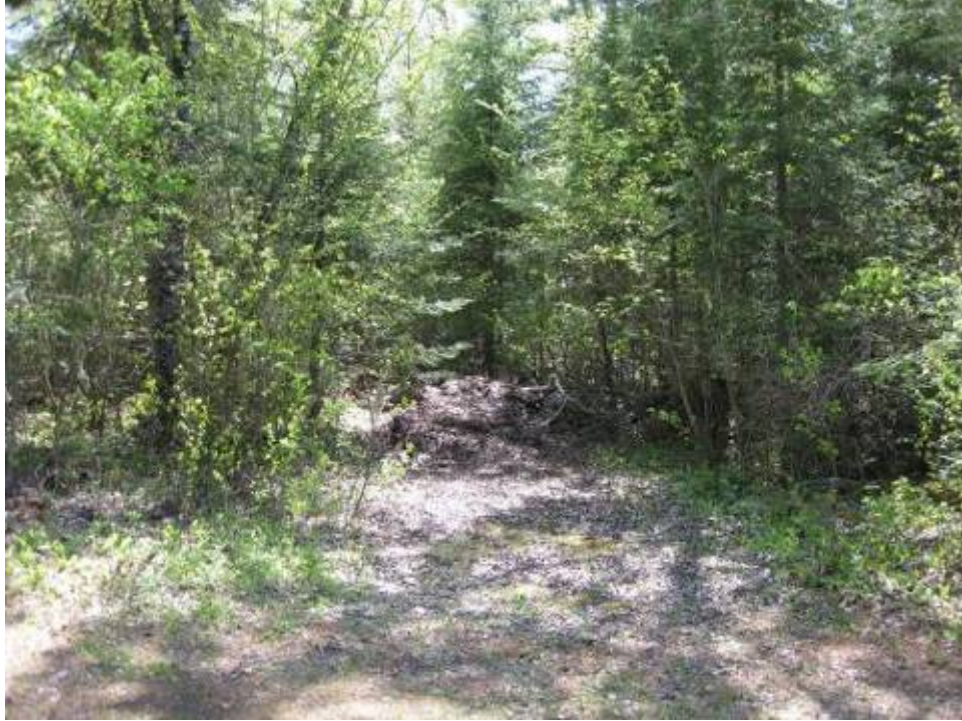
**Figure 10.** Northernmost spur road lacks historic integrity and is considered a non-contributing feature of the historic district. (J. Ferguson: June 2, 2009)

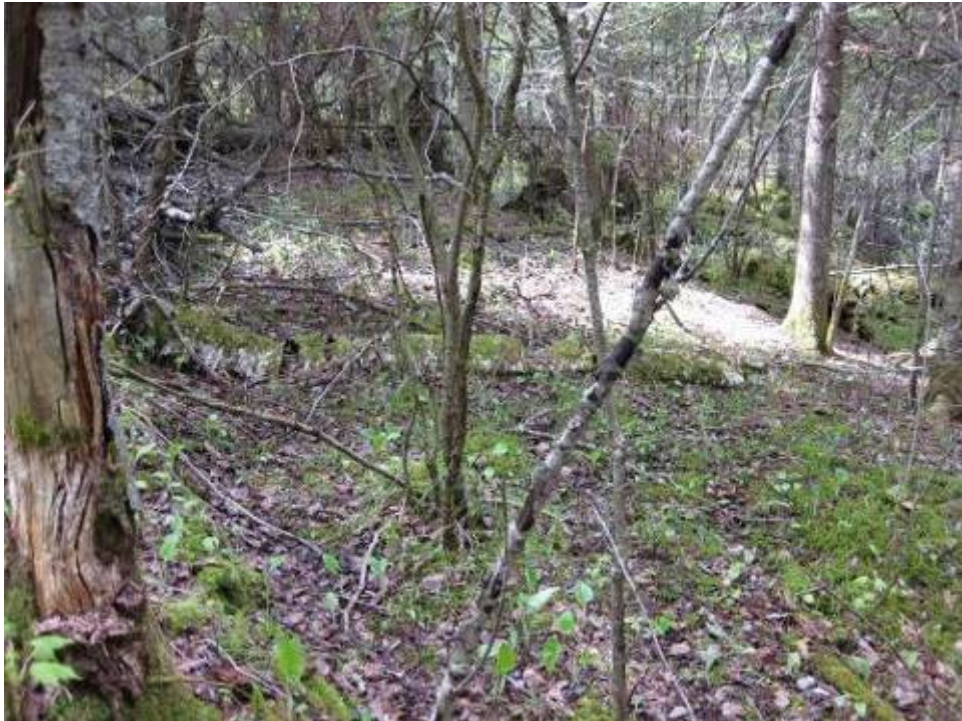
**Figure 11.** Southernmost spur road lacks historic integrity and is considered a non-contributing feature of the historic district. (J. Ferguson: June 2, 2009)

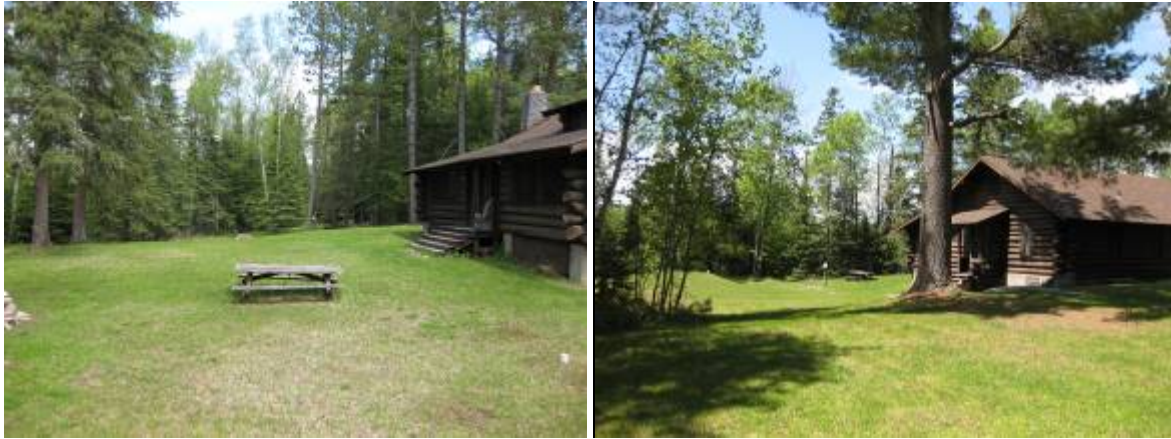
**Figure 13.** Domestic lawns surround the Ranger Dwelling (FS Bldg. #31101) and the LSFES Office and Dwelling (FS Bldg. #31108). Lawns are considered contributing features of the historic district. (J. Ferguson: June 2, 2009)

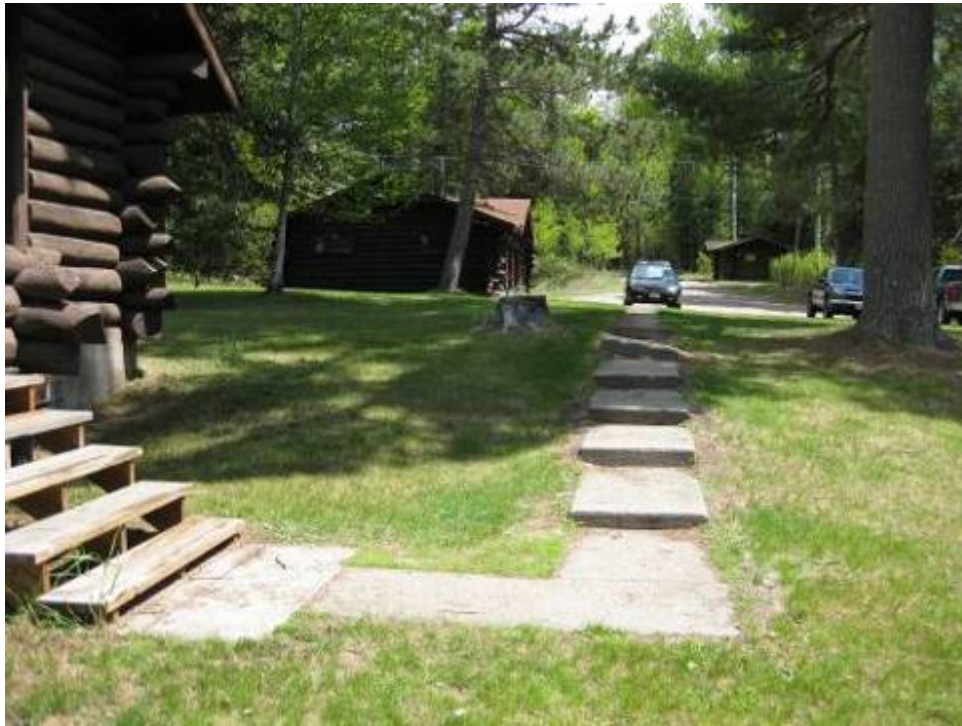
**Figure 14.** Concrete walkway connecting the main drive to the Ranger Dwelling is a contributing feature. (J. Ferguson: June 2, 2009)

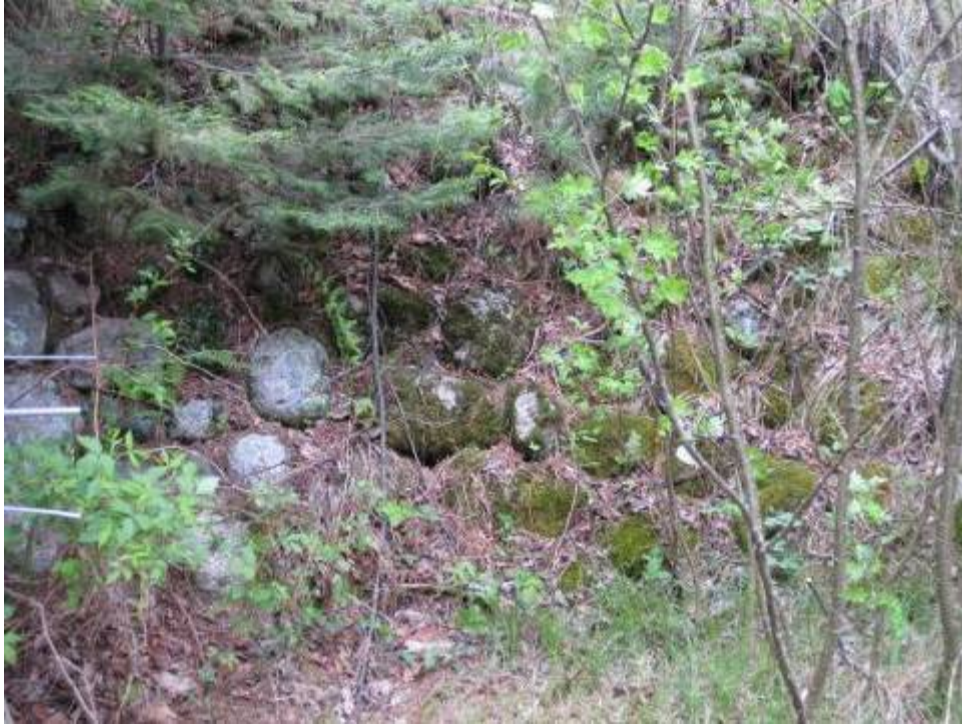
**Figure 15.** Stone retaining wall located between the Warehouse/Garage (FS Bldg. #31106) and the Cellar (FS Bldg. #31103) is a contributing feature. (J. Ferguson: June 2, 2009)

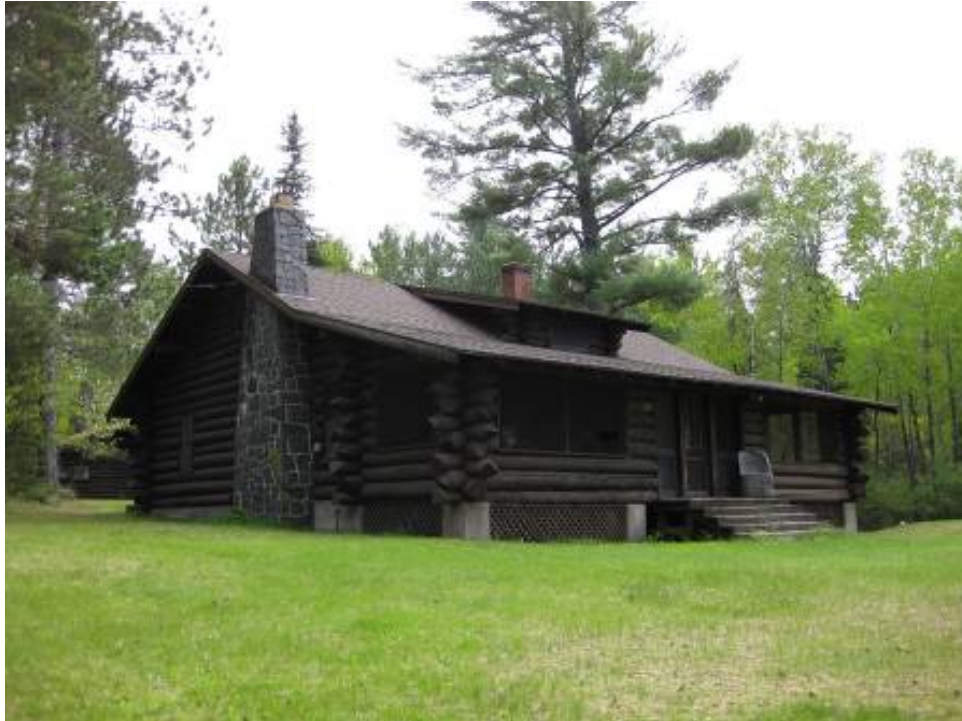
**Figure 17.** Ranger Dwelling west (front) elevation. (J. Ferguson: June 2, 2009)

that are approximately 3' x 3' square. The walls are constructed with peeled round logs prepared from locally available pine and aspen logs (Dunn 1997) that were laid with alternating butt and tip ends and connected by means of a standard saddle-notch. In keeping with the rustic style, log ends were intentionally cut to run proud of the wall intersection and finished by shaping the ends to chisel-edge point. In order to facilitate a tight, weatherproof fit, the underside of each log was prepared by shaping a groove or flute along its entire length. The roof of the Ranger Dwelling was constructed with purlins made of small diameter logs and covered with twelve inch wide dimensional lumber. The original roof covering was likely cedar shake.

Overall, with the exception of the exterior finish and some minor detailing, the Ranger Dwelling has changed little from its original form, shape, and layout. Furthermore, it has retained most of its significant architectural and stylistic elements (See Figure 18). Alterations since construction are minor and consist of several episodes of exterior repainting, replacement of window screening, replacement of front and side entrance stoops, and several episodes of roof re-shingling—including the most recent one witnessed by the heritage resources staff during a photographic survey trip in the fall of 2006. The most significant change was the removal of the log railing on the front entrance stoop, which can be seen in a 1934 photograph of the front elevation (See Figure 18). The date of this alteration is unknown but was probably completed when the present version of the front stoop was constructed.

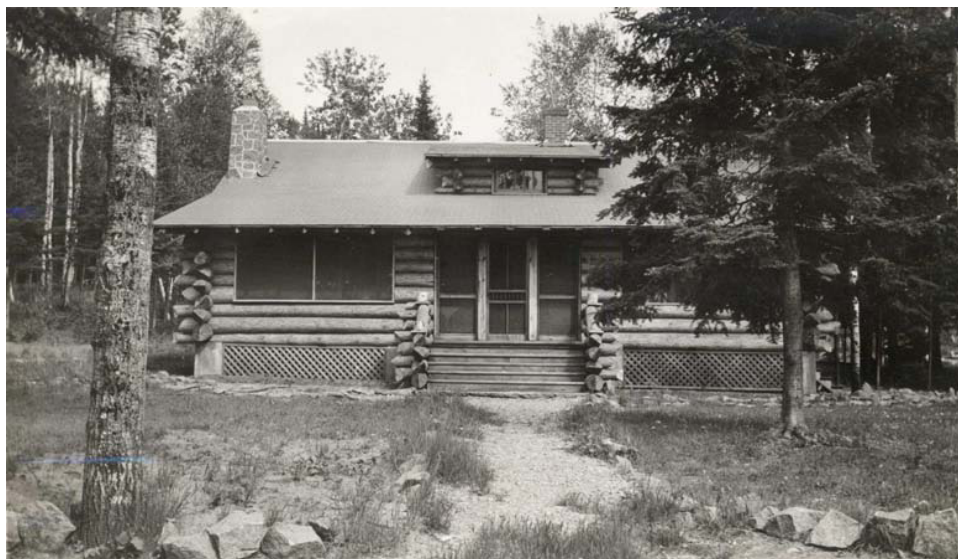
**Figure 18.** Front view of the Ranger Dwelling in 1934. Exposure was taken from the west. (Photo courtesy of Superior National Forest.)

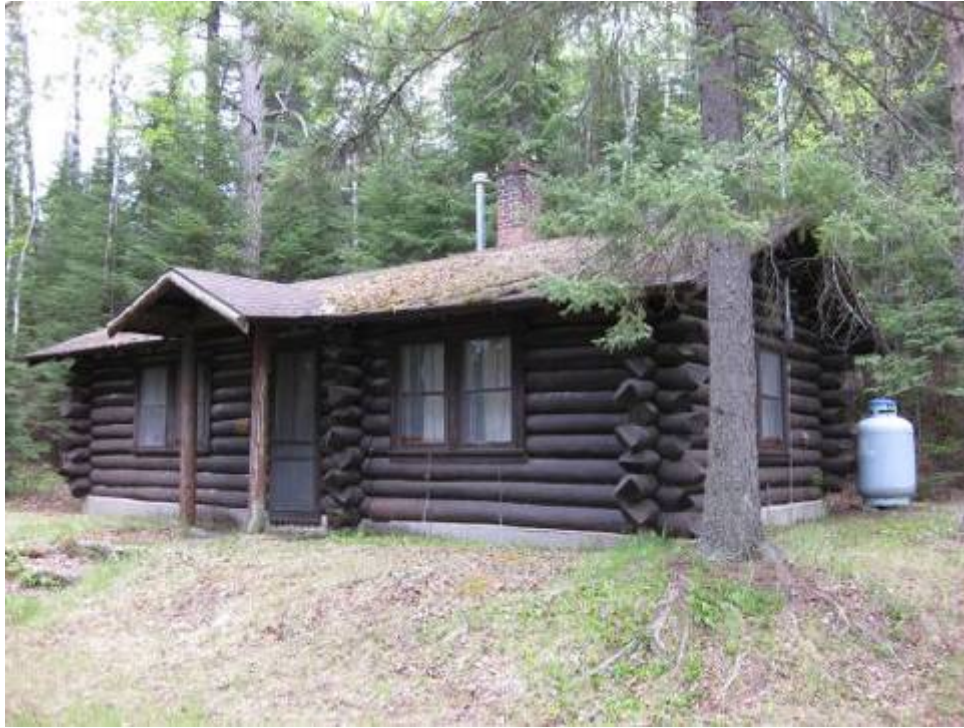
**Figure 19.** District Office Building northwest (front) elevation. (J. Ferguson: June 2, 2009)

The Office Building is situated on a poured concrete foundation, approximately twelve inches in height. The exterior walls are constructed of round logs and are fitted in the same manner as the Ranger Dwelling (See Page 31-32). The roof is constructed with one-inch dimensional lumber sheathing laid perpendicular to four log purlins tied into the top of the gable walls and supported by a central partition wall.

Based on survey and photographic evidence the District Office Building has undergone more significant alterations than any of the contributing buildings within the historic district (See Figure 20). The most striking of these changes are the bedroom and bathroom additions. The building was originally constructed with a one-room floor plan. Some time before 1947, a smaller room, (the present bedroom), was attached to the southwestern wall and made accessible by cutting in, and installing, the present doorway. The original window for this wall has been filled in but is still discernible. Photographic evidence shows that construction of the bedroom addition must have occurred within a 14-year period after the building's initial construction. However, the bathroom addition's construction date remains unknown.

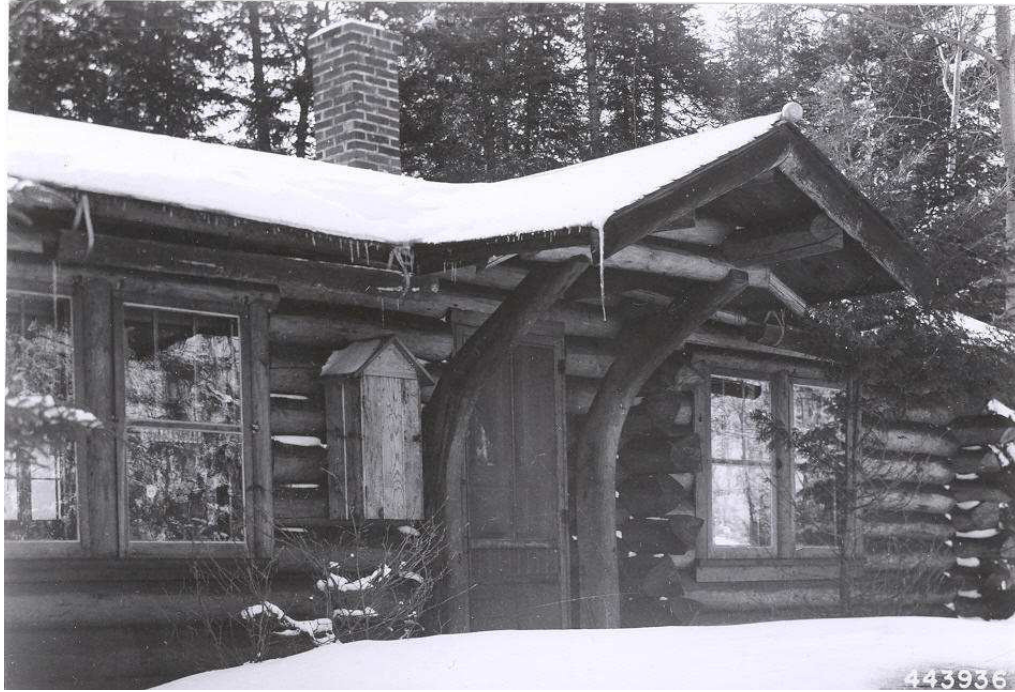
Another significant alteration was the complete replacement of the original support posts for the porch cover (See Figure 20). Originally, the posts consisted of two bent logs that flanked the front entrance door. Each log was connected to the wall in an unknown fashion and angled upward roughly from the door's midpoint to meet with a central support log. The date of this alteration is unknown but it took place sometime after 1947.

**Figure 20.** Front (northwest) view of the District Office building in 1947. View is from the north-northwest. Note the curved log brackets supporting the porch roof and hanging half-log gutters. (Photo courtesy of Superior National Forest).

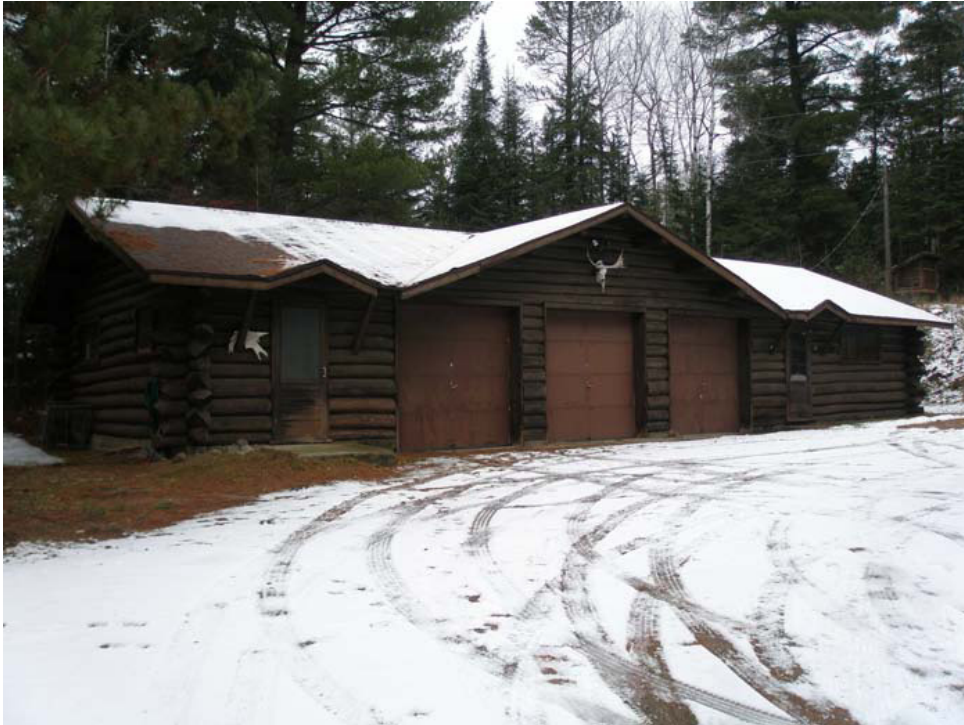
**Figure 21.** Warehouse/Garage southwest (front) elevation. Note original herring-bone doors have been replaced. (Photo courtesy of Superior National Forest, 2006)

The structural system for the Warehouse Building is similar in design, materials, and construction to the Ranger Dwelling with the exception of the floor construction (See Page 31-32). The foundation consists of a short wall made from poured concrete that runs underneath each wall. This foundation wall, which encompasses the entire building plan, surrounds a poured

Alterations to the original construction of the Warehouse Building include the replacement of all the exterior doors and the addition of supporting brackets to both the small porch covers (See Figure 22). The original door construction consists of board-and-batten covered on the exterior with wainscoting set in a diamond pattern. Remaining examples of this door type hang on the front entrance of the Oil House, the front entrance of the Sauna/Outhouse, and a variation on the front entrance of the Boat House. The date of these alterations is unknown. The Warehouse has experienced some structural degradation from powder post beetle infestation.

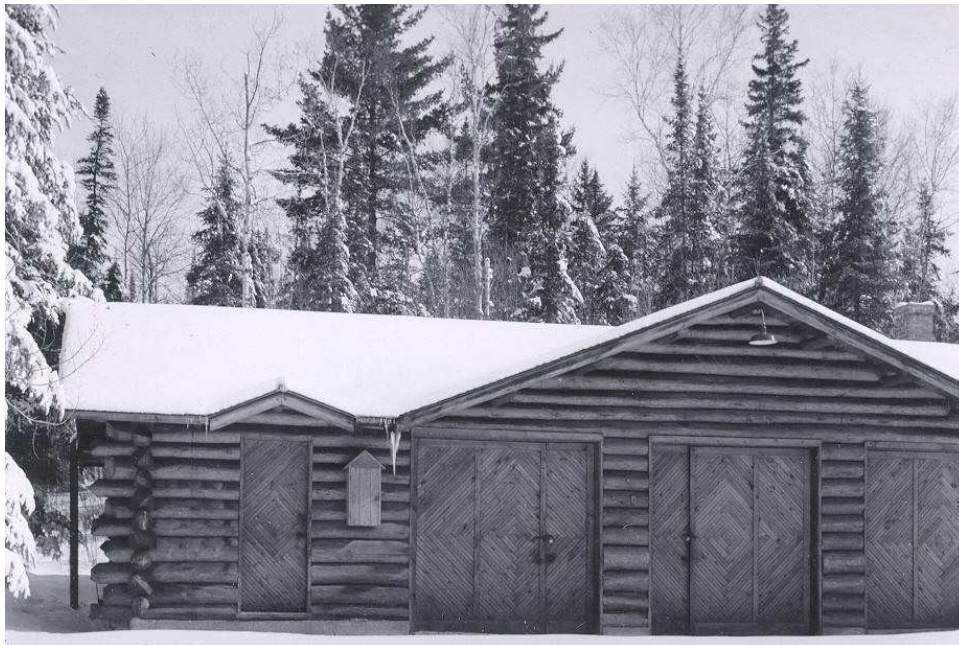
**Figure 22.** View of the left side of the Warehouse in 1947. (Photo courtesy of Superior National Forest).

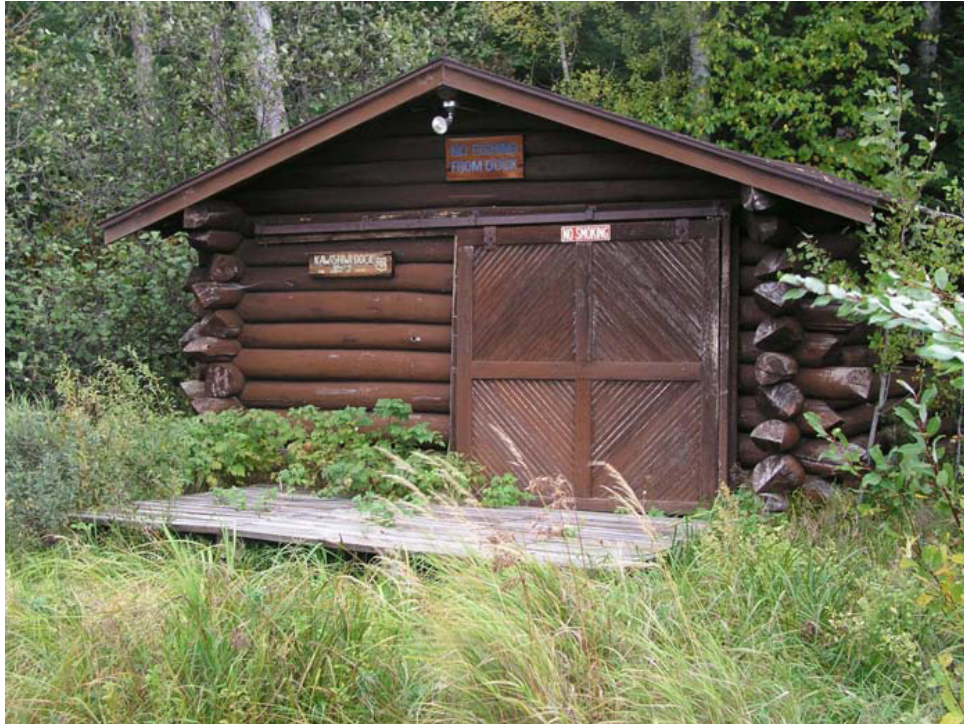
**Figure 23.** Boat House northwest (front) elevation. Note newer dock.  
(Photo courtesy of Superior National Forest, 2006)

The Boat house has received very few alterations except the removal of the original boat ramp which consisted of iron rails and a dock. There has been some structural degradation from powder post beetle infestation.

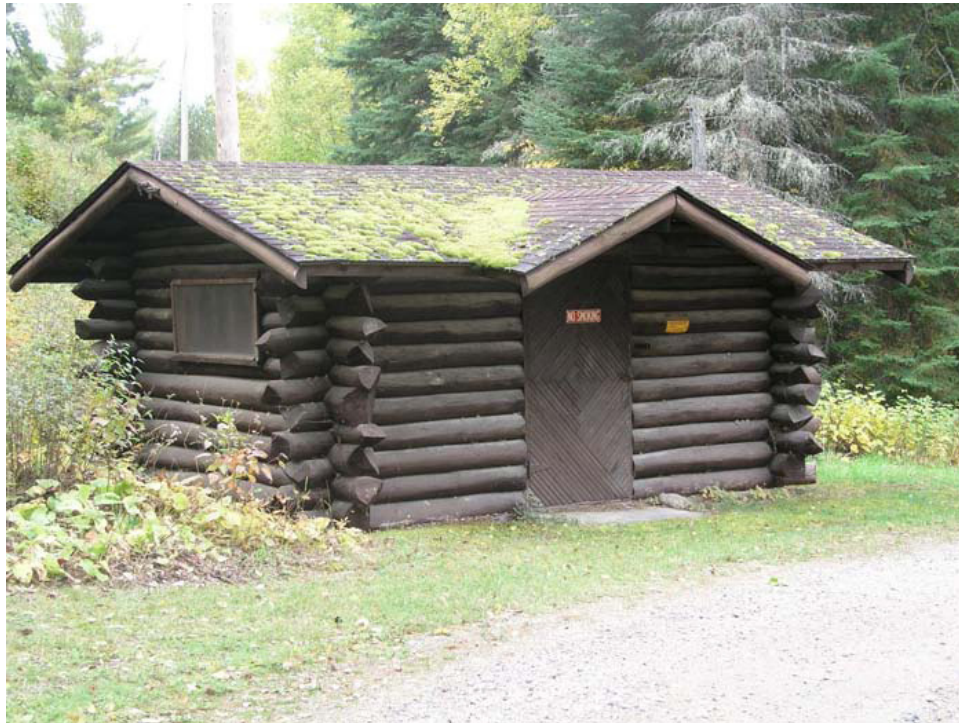
Figure 24. Oil house north (front) elevation. (Photo courtesy Superior National Forest, 2006)

The Oil House has experienced very few alterations except the removal of the original windows and some structural degradation from powder post beetle infestation.

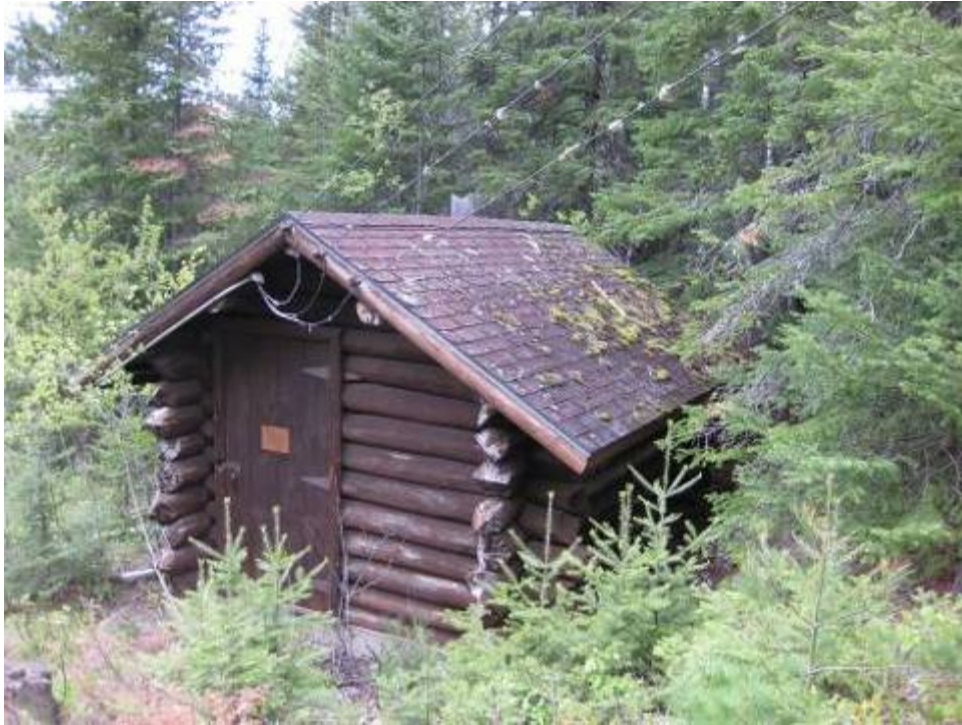
Figure 25. Pump House southwest (front) elevation. (J. Ferguson: June 2, 2009)

The Pump House has experienced very few alterations, with the exception of slight structural degradation from powder post beetle infestation.

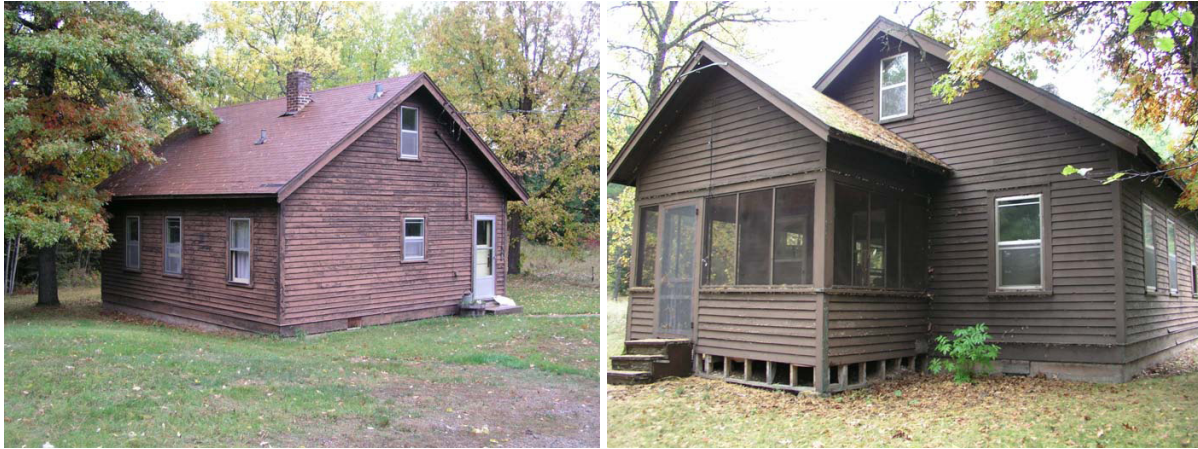
Figure 26. LSFES Office/Dwelling east (front) and west (rear) elevations. (Photo courtesy of Superior National Forest, 2006)

The LSFES Office and Dwelling is a front-gabled, one-and-a-half-story, wood framed building with a medium pitched gable roof. It also features wide, exposed eave-overhangs (Figure 26). The building's foundation consists of poured concrete. The walls and both gabled roofs are balloon framed. This building served multiple purposes for the LSFES as an office, laboratory and bachelor's quarters. It was built in 1931 and is the oldest extant administrative building on the Superior National Forest. The building is oriented so that its front gable entrance-wall faces roughly toward the northwest and the west shore of the South Kawishiwi River.

Based on limited information, the LSFES Dwelling appears to have been relatively unaltered since its construction. The few notable alterations, based on photographic evidence, include the addition of aluminum inserts on all the windows and the replacement of the original doors.

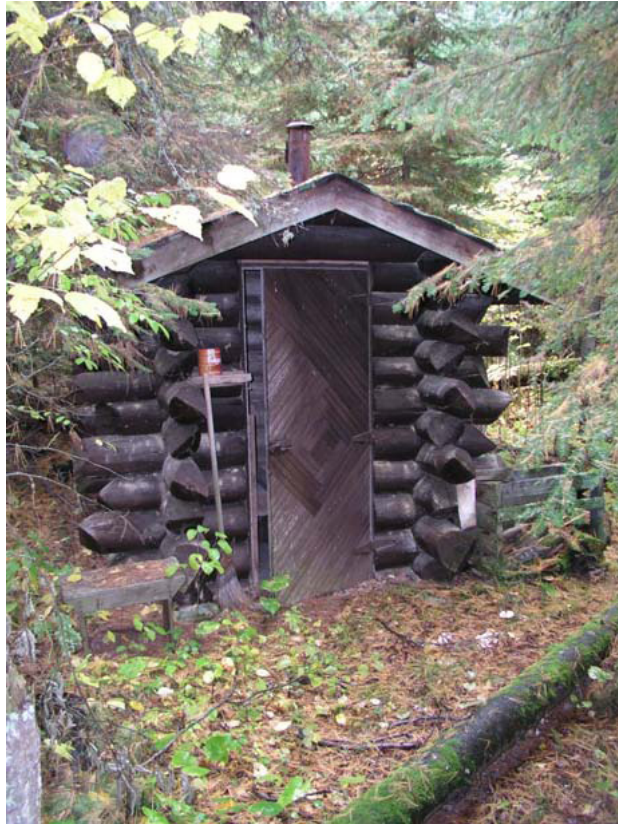
**Figure 27.** Outhouse, front (south) elevation. Note reoccurrence of diamond pattern door. (Photo courtesy of Superior National Forest, 2006)

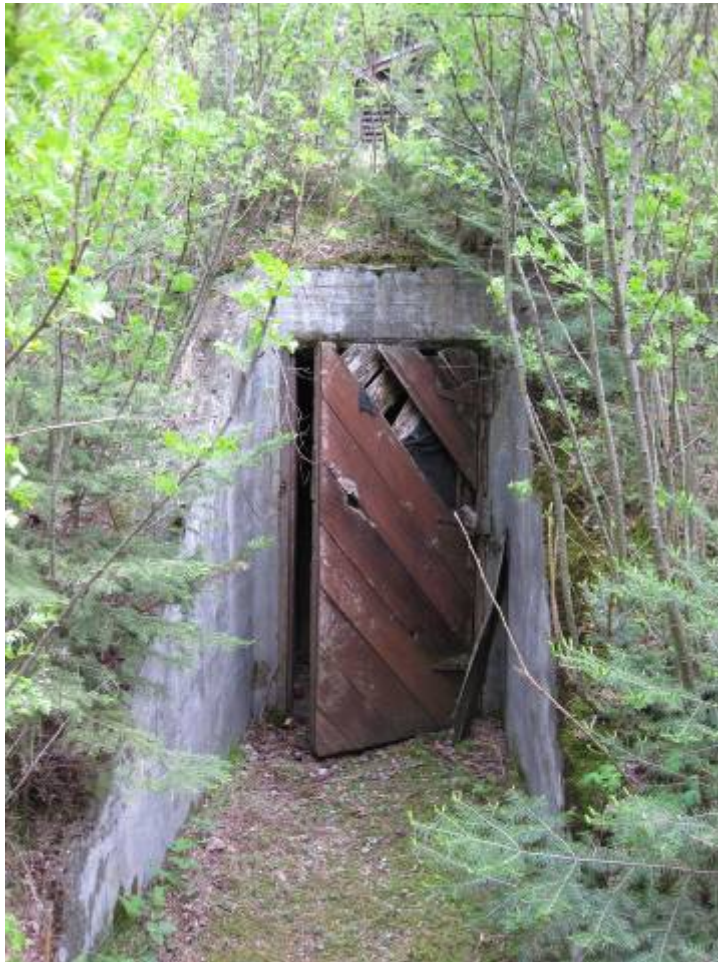
Figure 28. Cellar west elevation. (J. Ferguson: June 2, 2009)

The Cellar (Figure 28) is a 12' x 12' subsurface enclosure constructed of poured cement with a dirt floor. Although its original purpose is unknown, it may have been used to store seedlings. The structure possesses a single entrance located on the west side. The interior of the structure is accessible through a single leaf door constructed planks of dimensional lumber. There is a vent stack positioned on the roof of the structure. The walls and roof are constructed of poured concrete.

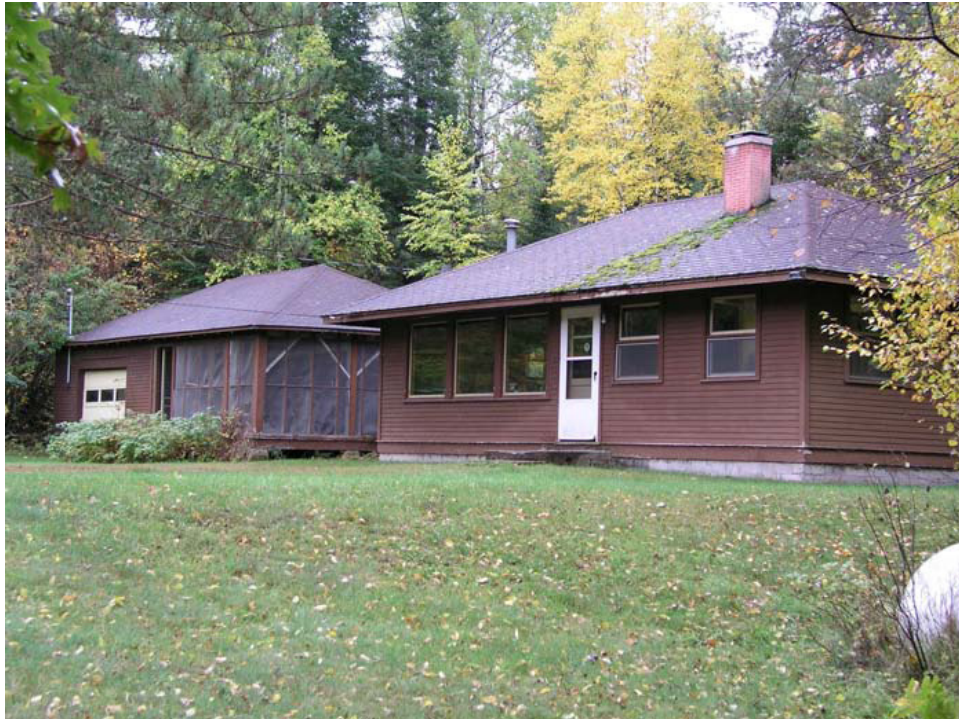
**Figure 29.** Laboratory (right) and Insectary (left) northeast (front) elevations. (J. Ferguson: June 2, 2009)

The LSFES Laboratory Building (Figure 29) is a single-story, wood framed, multi-room dwelling built according to a massed, rectangular floor plan capped with a low-pitched hip roof featuring wide, unboxed eave-overhangs. The building was built as a laboratory space in 1957 and now serves as an office space. The walls of the building are sided with short-reveal lap siding that is tied into corner boards and the narrow window casings. The building features multiple double-hung and casement windows as well as a wooden interior and metal exterior door set. The front elevation also features a course of three large picture windows. The building is oriented on the landscape with its long axis laid out in a general east west direction. The front elevation faces roughly to the north. There is a red brick chimney extending above the roof ridge on the right side of the roof's northeast slope. The building rests on concrete cinder block foundation.

The Insectary/Garage (Figure 29) is a single-story, wood framed, two-unit building covered by a low pitched hip roof. Built in 1957, the same year as the Laboratory Building, the Insectary was initially utilized as a space to raise various species of insects for forestry-related research. It now serves as a storage space. Like the Laboratory Building, the long axis of the Insectary is laid out in an east-west direction. The building possesses a garage space on the eastern end and an open space, presumably for raising insects, on the west end that is enclosed with floor-to-ceiling screening. The single-leaf, main entrance door to the building is located in the center of the front wall. The building rests on concrete footings for the screened area and a concrete foundation for the garage area. The screened area is supported by a wooden joist system constructed with dimensional lumber. The garage portion of the building has a concrete slab for a floor.

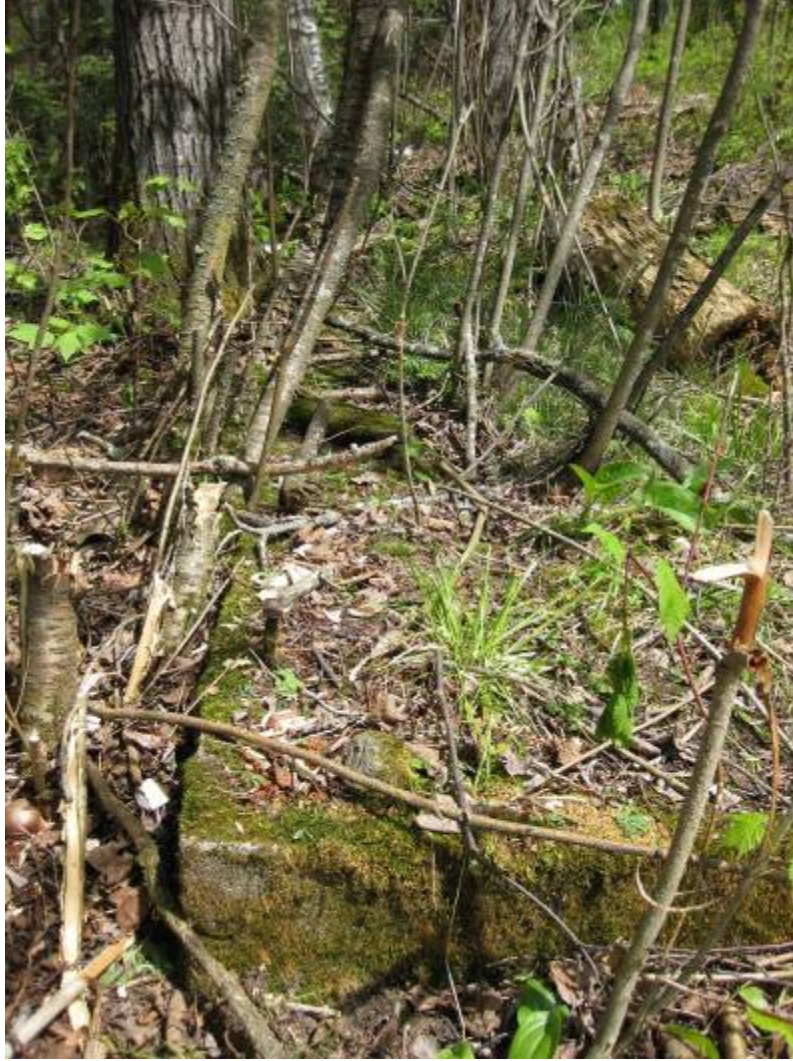
Figure 33. Oil House foundation. (J. Ferguson: June 2, 2009)

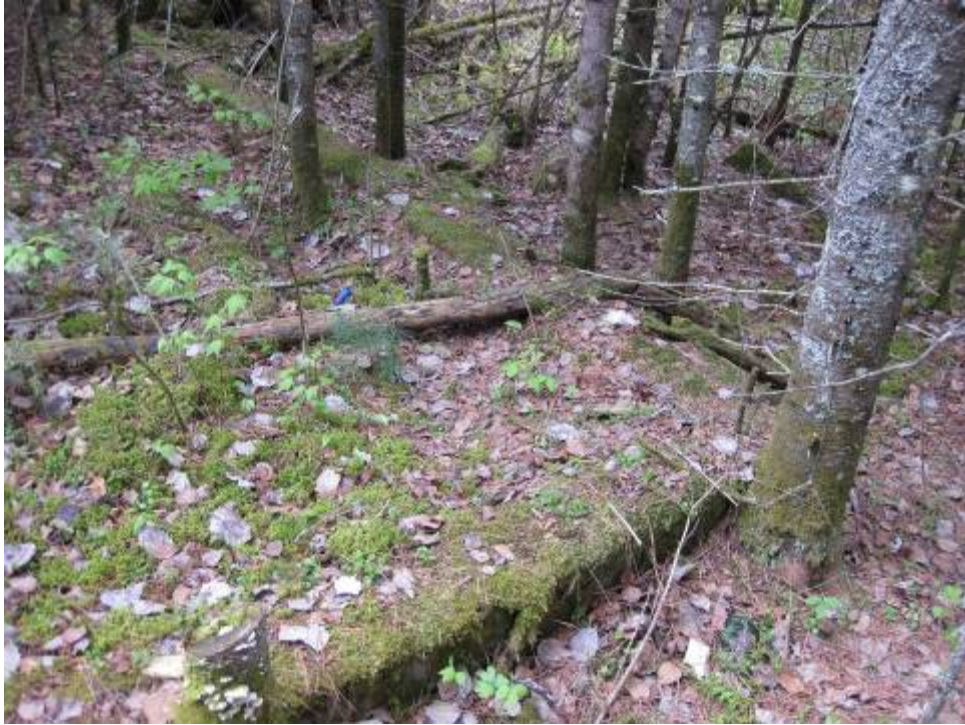
**Figure 34.** Warehouse foundation (representative of both). (J. Ferguson: June 2, 2009)
