# HALFWAY RANGER STATION HISTORIC DISTRICT

## §106 RESOURCE AND BOUNDARY DELINEATION REPORT

October 28, 2009

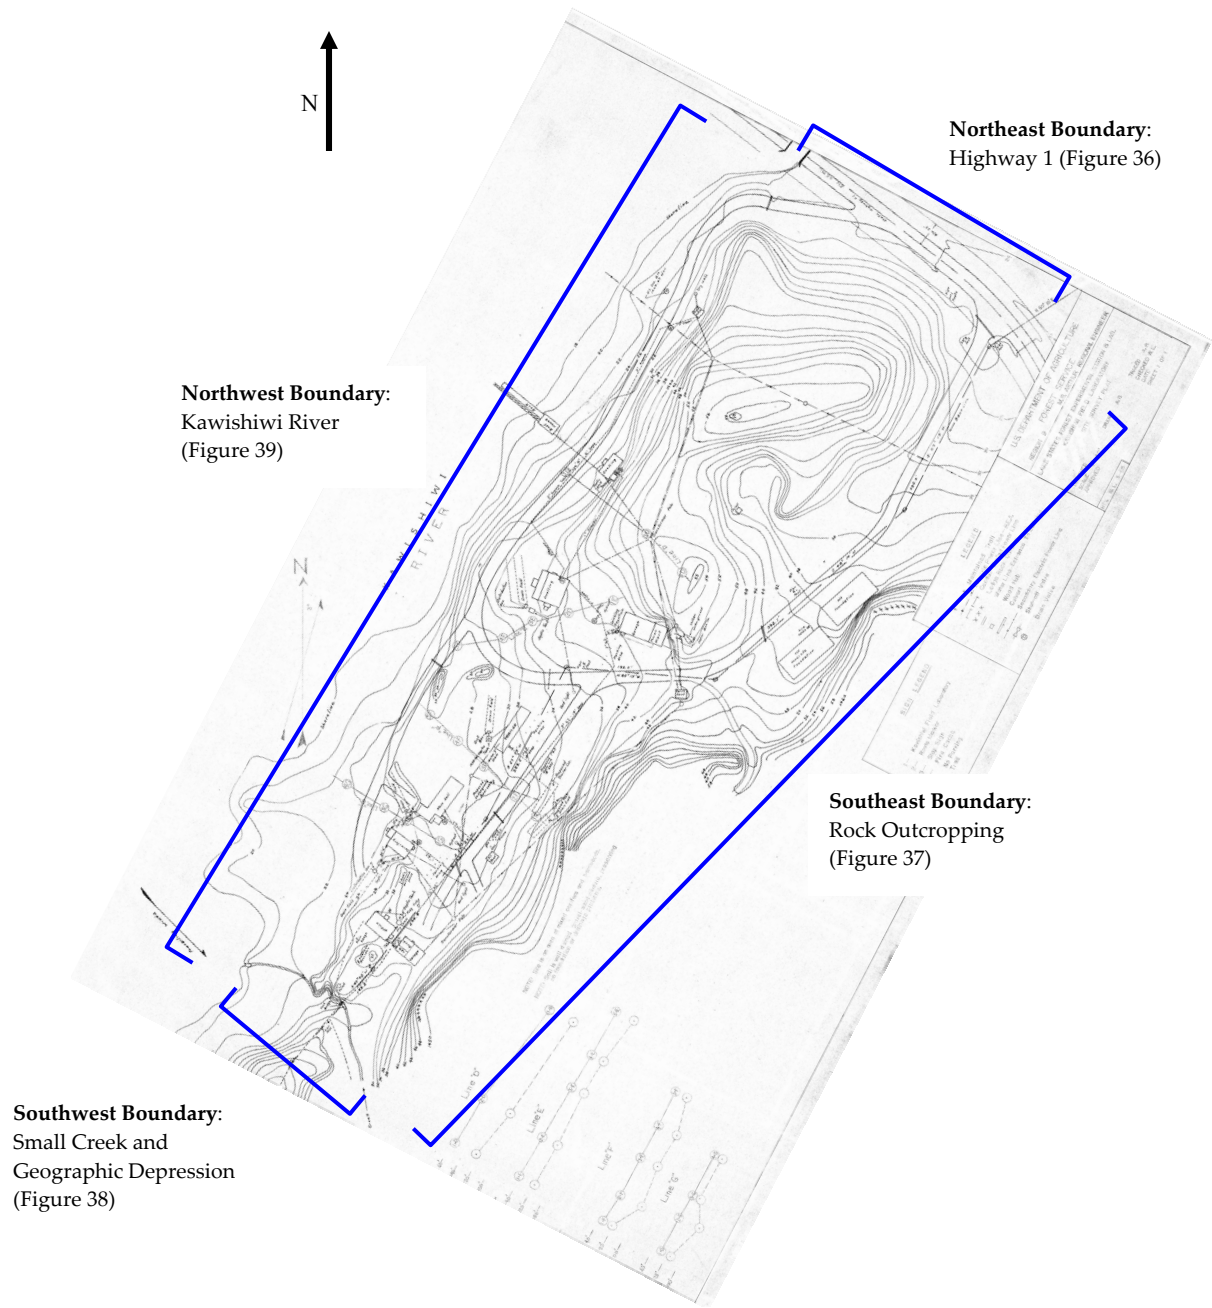
**Figure 35.** Halfway Ranger Station Topographic Site Plan showing the HRSHD's natural boundaries (1965).

The HRSHD is located in Township 62 North, Range 11 West, Section 33, 4<sup>th</sup> P.M. Babbitt, Minnesota 7.5" USGS Quadrangle Map (See Figure 41 for more specific data). The site is situated adjacent to the South Kawishiwi River, approximately twelve miles southeast of Ely, Minnesota in Lake County. The Facility occupies a twelve acre parcel of land and features distinct geographic boundaries on all sides. Generally oriented obliquely toward the northeast, the Property's northeastern boundary is Highway 1, at which the HRSHD can be accessed at two points, its entire southeastern boundary is marked by a prominent rock outcropping, its southwest boundary is marked by a small creek (name unknown) which drains into the South Kawishiwi River and a geographic depression, and its northwestern boundary is the South Kawishiwi River. Below is a topographic site plan which accurately depicts the HRSHD's historic boundaries (Figure 35), followed by photographs of each boundary feature (Figures 36-39), an area map (Figure 40), and a USGS topographic map (Figure 41).

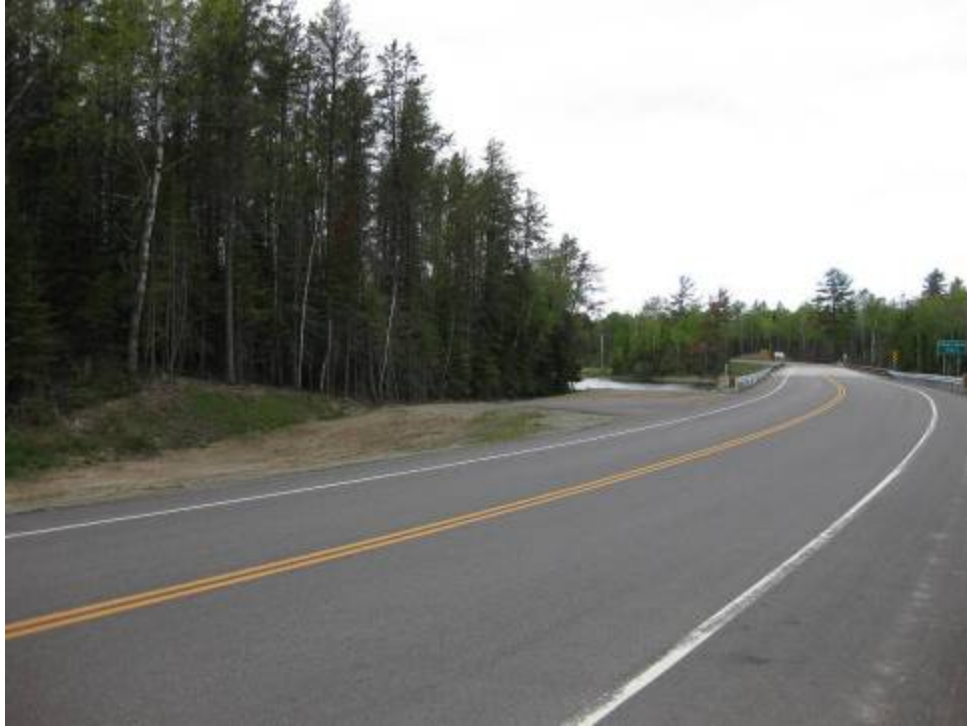
**Figure 36.** Northeast Boundary: Highway 1 (J. Ferguson: June 2, 2009).

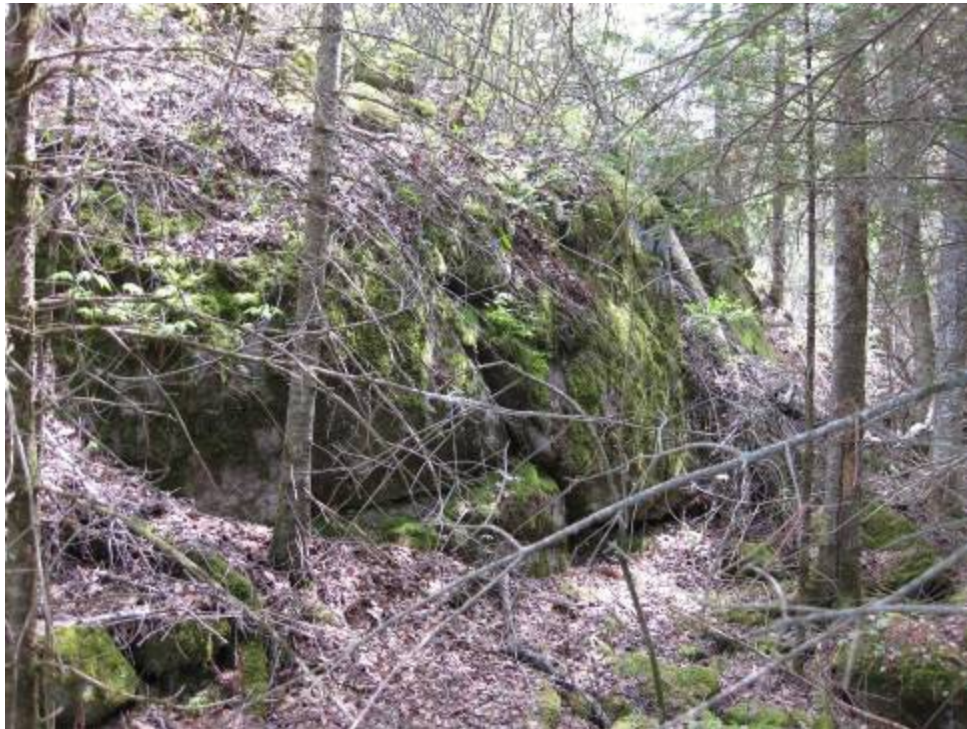
**Figure 37.** Southeast Boundary: Rock Outcropping (J. Ferguson: June 2, 2009).

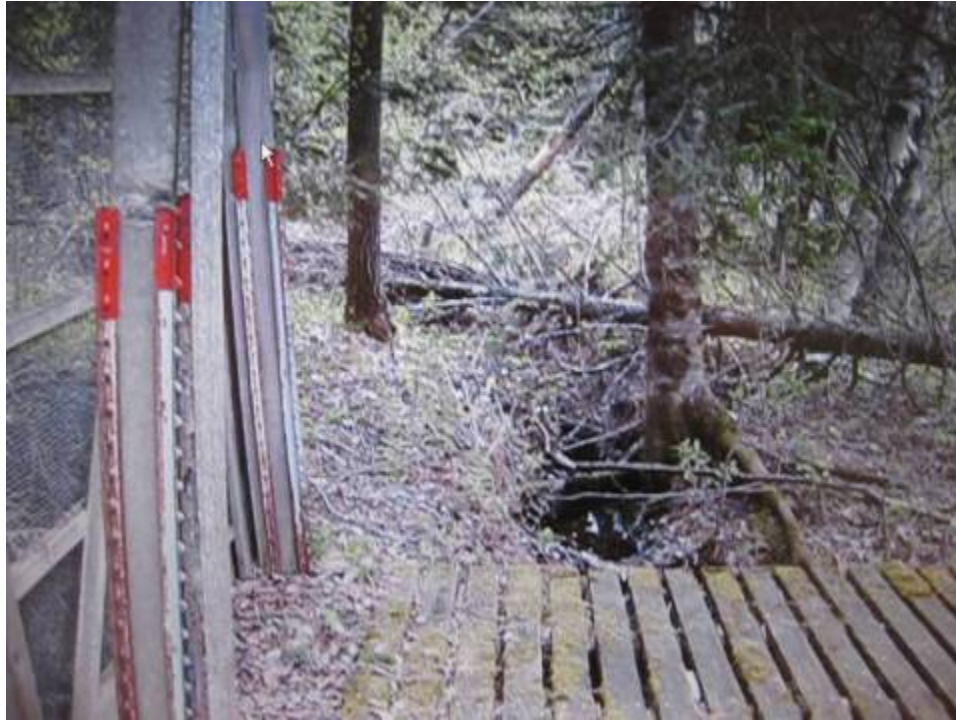
**Figure 38.** Southwest Boundary: Small Creek and Geographic Depression (J. Ferguson: June 2, 2009).

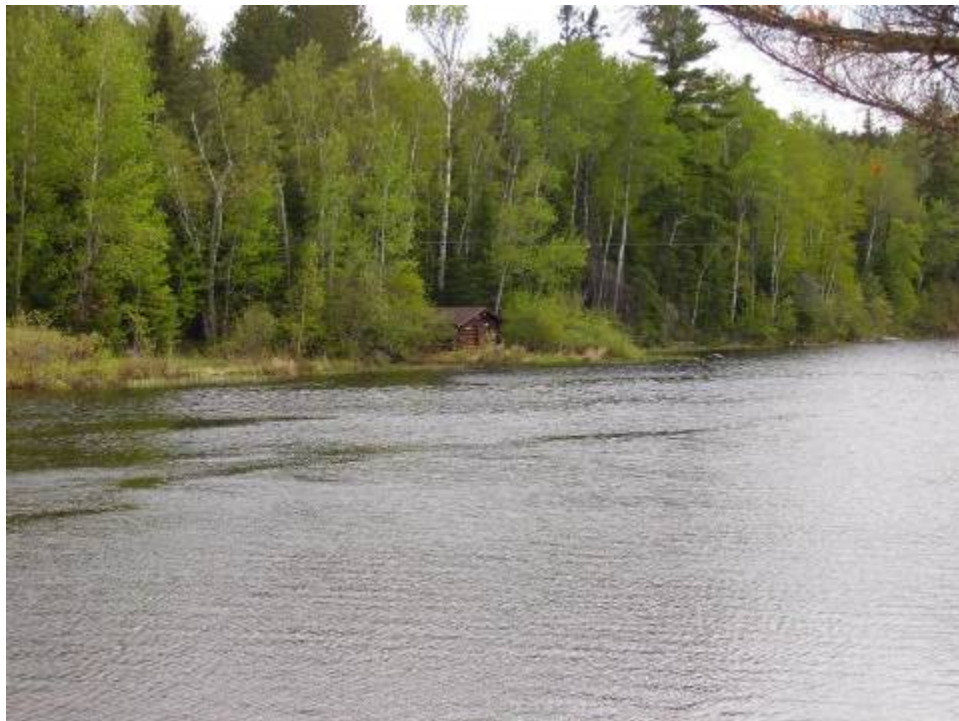
**Figure 39.** Northwest Boundary: South Kawishiwi River (J. Ferguson: June 2, 2009).
